PHMC Lessons Learned Fluor Hanford Inc. Just-In-Time Report

Deficient Supplied Air Respirator Check Valves Identified

January 31, 2007

2007-RL-HNF-0005

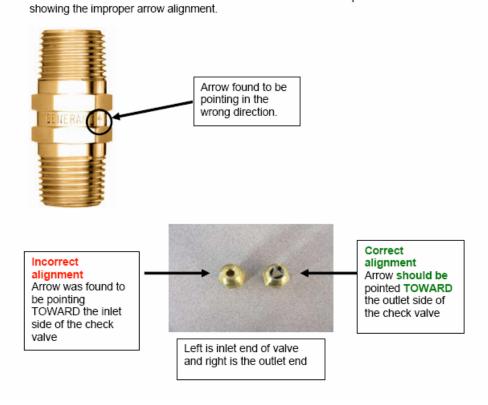
Event: An employee at the Advanced Mixed Waste Treatment Project in Idaho identified deficient check valves when preparing to install replacement valves on a PremAire® supplied air respirator unit. The units were being configured to allow a dual-air supply for a new application. The deficient check valves had stamped arrows on them indicating improper air-flow direction/alignment used for installation.

The check valves are MSA part number 630326 and are installed prior to a filter assembly (MSA part # 811940) attached to the main PremAire® manifold (part # 496880) when configuring for a dual air supply. The two deficient check valves had stamped arrows on them indicating **improper** air-flow direction/alignment used for installation. The manufacture has been notified. See the photos

Managers/Supervisors	Workers
An event as unlikely as the flow arrow being stamped backwards may be unlikely, but it does happen so always report any concerns.	Always check equipment when doffing to ensure it will operate properly.
If any of the dual-airline PremAire units are encountered, tag them out of service and notify the FH Respiratory Protection Program Administrator.
